PRIMARY RECORD

* Resource Name or #: 12291 Martha Ann Drive

Section 106 Compliance

Intensive Survey

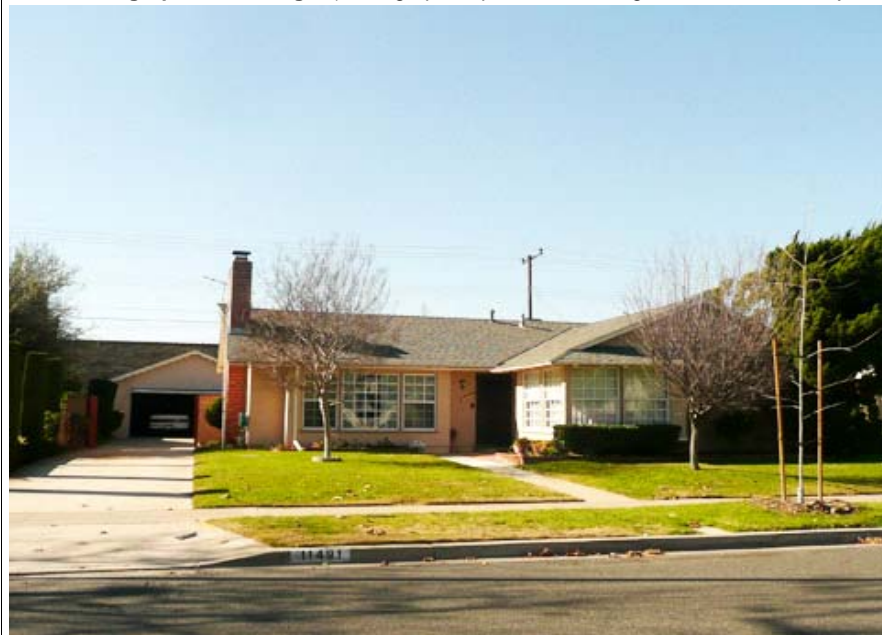
* P3a. Description: (Describe resource and its major elements. Include design, materials, condition, alterations, size, setting, and boundaries.)
The one-story Ranch style building is 'L'-shaped in plan. The cross gable/gable on hip roof, with flared gable heads and boxed eaves, is clad in composition shingles. A brick chimney is located on the southern façade of the building. The exterior walls are clad in smooth textured stucco. The windows have been replaced with vinyl sash and fixed-pane units. The primary entrance is recessed. A detached garage is located in the rear of the parcel. The building does not meet the NRHP and CRHR eligibility criteria for the reasons identified on the district record prepared for this subdivision; therefore the building does not contribute to a historic district and is not individually eligible for listing in the NRHP and the CRHR.

Facing west; 2/10/2010; Photo No.

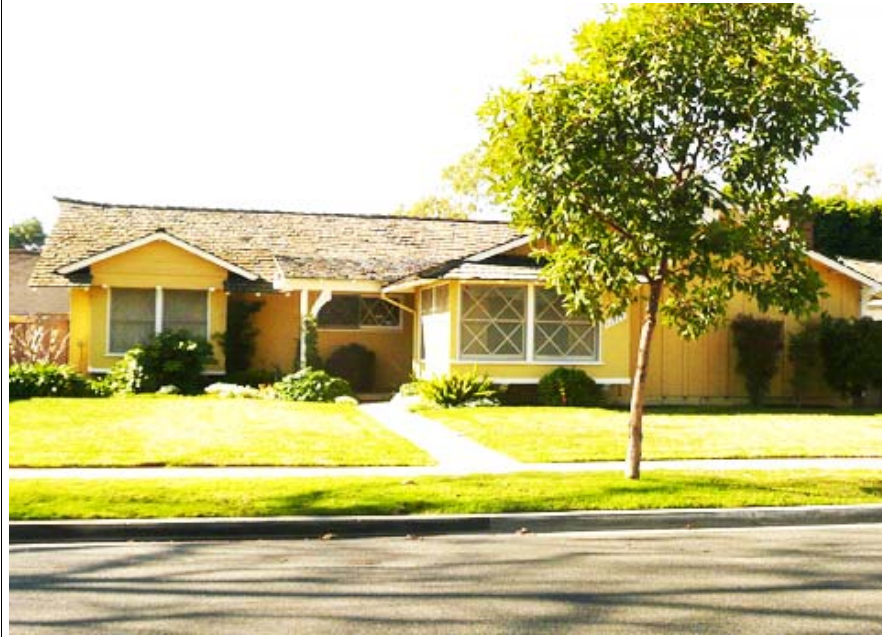
* P3a. Description: (Describe resource and its major elements. Include design, materials, condition, alterations, size, setting, and boundaries.)
The one-story Ranch style building is 'L'-shaped in plan. The cross gabled roof, with flared gable heads and boxed eaves, is clad in wood shingles. The northern end of the northern front-facing gable is accented with a bracket. The exterior walls are clad in smooth textured stucco and vertical board and batten siding, and the southern front-facing gable is clad in horizontal wood siding. The projecting bays on the primary (eastern) façade are accented with corbels. The diamond-paned wood sash and sliding windows appear to be original. The primary entrance is raised, recessed, and accessed via a cast concrete porch. A wood square post with brackets supports the porch roof. The building does not meet the NRHP and CRHR eligibility criteria for the reasons identified on the district record prepared for this subdivision; therefore the building does not contribute to a historic district and is not individually eligible for listing in the NRHP and the CRHR.

Facing west; 2/10/2010; Photo NO.

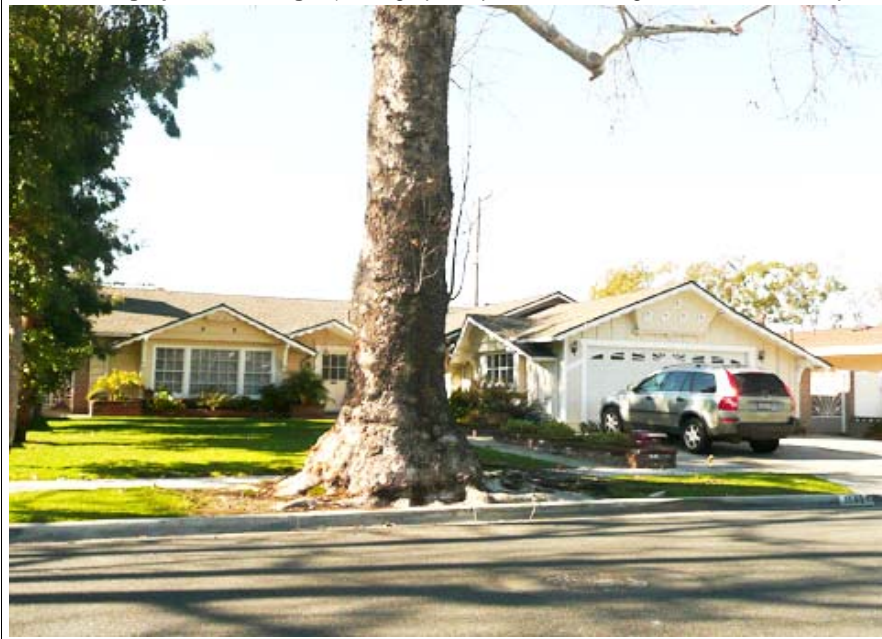
* P3a. Description: (Describe resource and its major elements. Include design, materials, condition, alterations, size, setting, and boundaries.)
The one-story Ranch style building is generally 'L'-shaped in plan. The cross gabled roof, with flared gable heads and boxed eaves, is clad in composition shingles. The front-facing gables are accented with scalloped barge board. The southern and northern front-facing gables are further accented with horizontal wood siding, brackets, and dove-cotes. The south-facing gable is accented with brackets and horizontal wood siding. The exterior walls are clad in horizontal wood siding with brick veneer to the water line, smooth textured stucco, and vertical board and batten siding. The multi-light wood casement windows appear to be original, but the majority of the windows have been replaced with vinyl sash units. The primary entrance is raised and accessed via a cast concrete porch. The building does not meet the NRHP and CRHR eligibility criteria for the reasons identified on the district record prepared for this subdivision; therefore the building does not contribute to a historic district and is not individually eligible for listing in the NRHP and the CRHR.

P5b. Description of Photo: (View, date, etc.)
Facing the primary façade, 2/10/2010; Photo No. P1030871.jpg

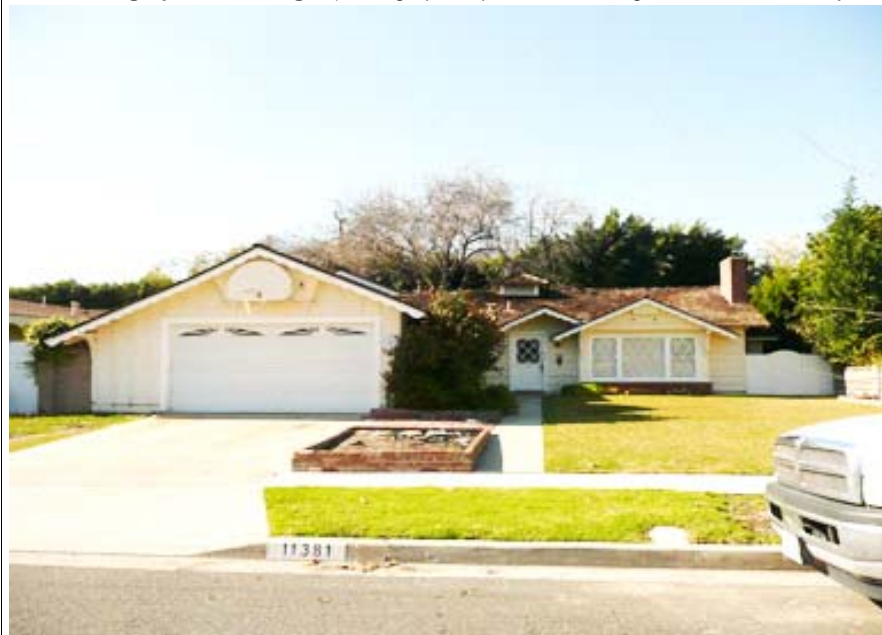
* P3a. Description: (Describe resource and its major elements. Include design, materials, condition, alterations, size, setting, and boundaries.)
The one-story Ranch style building is 'L'-shaped in plan. The cross gabled roof, with boxed eaves, is clad in wood shingles. A cupola is centrally located on the roof crest. A brick chimney is located on the north elevation. The front-facing gables are accented with scalloped barge board. The northern and southern front-facing gables are further accented with dovescotes. The exterior walls are clad in vertical board and batten siding, smooth textured stucco, and horizontal wood siding. A projecting bay on the northern end of the primary (eastern) façade is accented with brick veneer to the water line and brackets in the eaves. The diamond-paned wood sash and fixed-pane windows appear to be original. The primary entrance is raised and accessed via a cast concrete porch. The building does not meet the NRHP and CRHR eligibility criteria for the reasons identified on the district record prepared for this subdivision; therefore the building does not contribute to a historic district and is not individually eligible for listing in the NRHP and the CRHR.

Facing west; 2/10/2010; Photo NO.

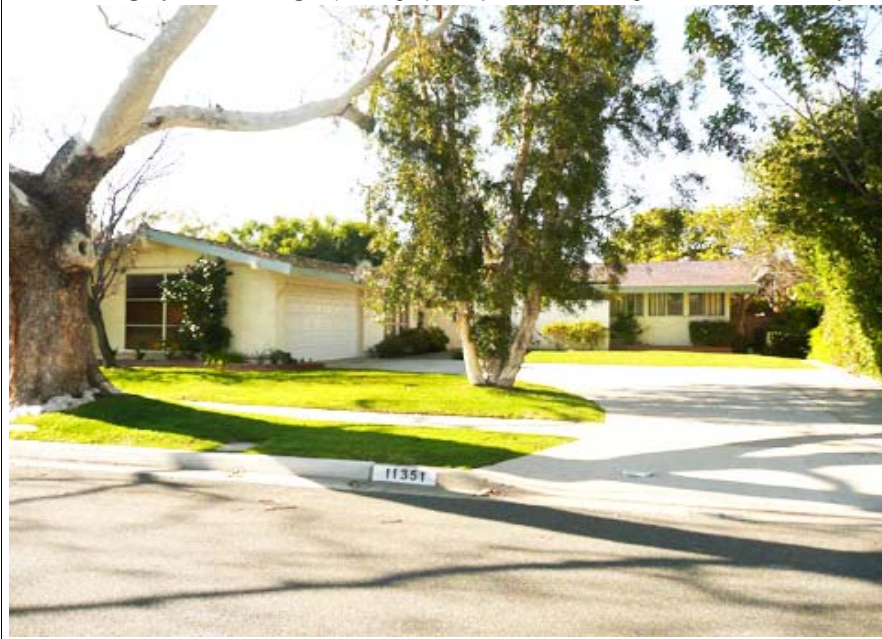
Facing the primary façade, 2/10/2010; Photo
No. P1030873.jpg

* P3a. Description: (Describe resource and its major elements. Include design, materials, condition, alterations, size, setting, and boundaries.)
the one-story Ranch style building is 'L'-shaped in plan. The cross gabled roof, with boxed eaves and flared gable heads, is clad in composition shingles. The gables are accented with false beams and false timbering. A brick chimney is prominently featured on the northern end of the primary (eastern) façade. The exterior walls are clad in smooth textured stucco, and the east façade of the attached two-car garage is accented with scored stucco. The aluminum sliding and casement windows appear to be original. The primary entrance is accessed via a cast concrete porch, which is partially enclosed with a brick wall. The building does not meet the NRHP and CRHR eligibility criteria for the reasons identified on the district record prepared for this subdivision; therefore the building does not contribute to a historic district and is not individually eligible for listing in the NRHP and the CRHR.

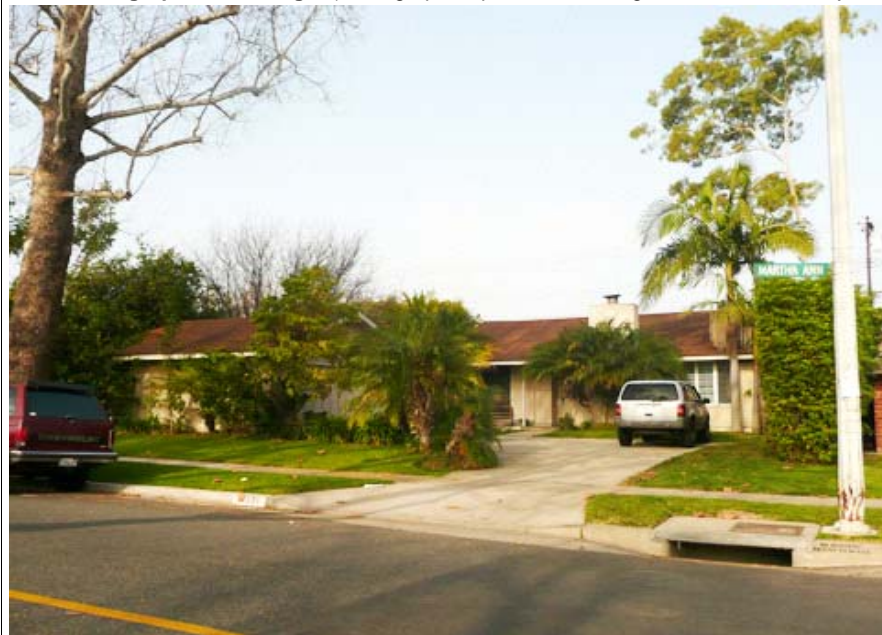
Facing the primary façade; 2/18/2010; Photo No. P1030896.jpg

* P3a. Description: (Describe resource and its major elements. Include design, materials, condition, alterations, size, setting, and boundaries.)
The one-story Ranch style building is rectangular in plan. The side gabled roof, with boxed eaves, is clad in composition shingles. A brick chimney is located off center on the northern end of the east face of the roof. The exterior walls are clad in board and batten siding. The wood two-over-two sash and casement windows appear to be original. The primary entrance is accessed via a covered porch, which spans the southern end of the primary (eastern) façade. The roof overhangs to shelter the entry porch, and is supported by square wood posts. A detached garage is located in the front of the parcel, and is of similar design and materials as the main building. The building does not meet the NRHP and CRHR eligibility criteria for the reasons identified on the district record prepared for this subdivision; therefore the building does not contribute to a historic district and is not individually eligible for listing in the NRHP and the CRHR.

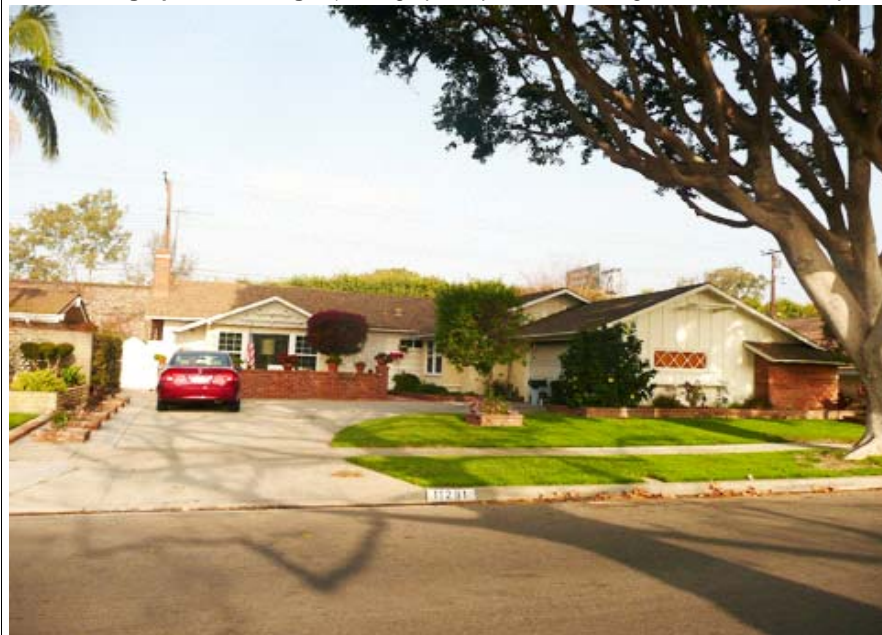
P5b. Description of Photo: (View, date, etc.)
Facing the primary façade; 2/18/2010; Photo No. P1030897.jpg

* P3a. Description: (Describe resource and its major elements. Include design, materials, condition, alterations, size, setting, and boundaries.)
The one-story Ranch style building is 'L'-shaped in plan. The cross gabled roof, with boxed eaves, is clad in composition shingles. A brick chimney is located at the southern end of the roof crest. The southern front-facing gable is accented with a dove-cote and brackets, and the northern gable is accented with a flowerbox ledge. The exterior walls are clad in wavy-edge vertical board and batten siding, smooth textured stucco, and horizontal wood siding. The majority of the windows were replaced with vinyl sliding and sash units. The eastern façade of the projecting attached two-car garage is accented with a diamond-pane fixed-pane window, with amber-tinted pebble glass, a second flowerbox ledge. The façade is further accented with a half-height bay, with brick veneer and a composition shingle-clad pent roof, which partially spans the northern end of the façade. A brick wall partially encloses a private courtyard, and it is not known if it is original to the building. The building does not meet the NRHP and CRHR eligibility criteria for the reasons identified on the district record prepared for this subdivision; therefore the building does not contribute to a historic district and is not individually eligible for listing in the NRHP and the CRHR.

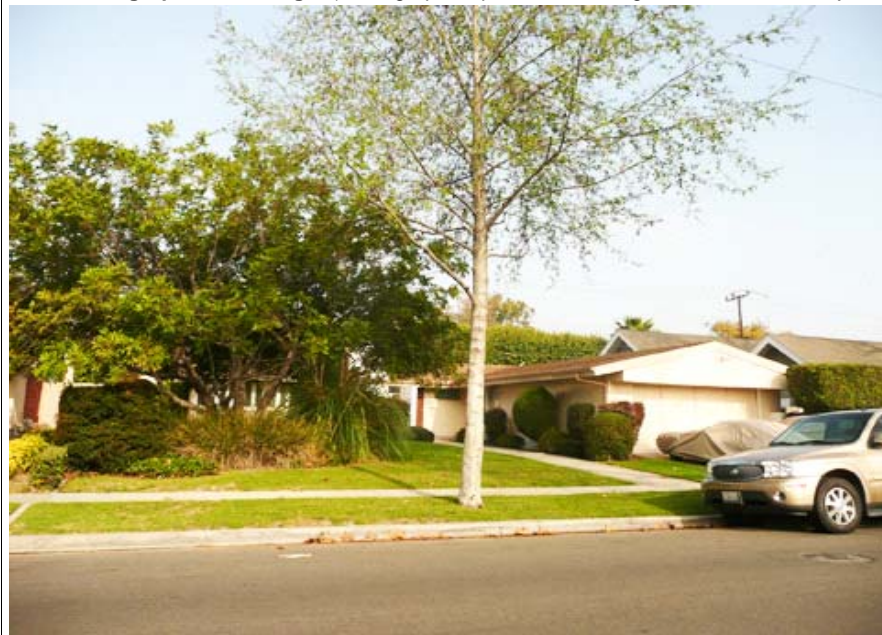
P5b. Description of Photo: (View, date, etc.)
Facing the primary façade; 2/18/2010; Photo No. P1030898.jpg

* P3a. Description: (Describe resource and its major elements. Include design, materials, condition, alterations, size, setting, and boundaries.)
The one-story Ranch style building is 'L'-shaped in plan. The cross gabled roof, with boxed eaves, is clad in composition shingles. A brick chimney, with brick accents, is prominently located on the southern end of the primary (eastern) façade. The exterior walls are clad in vertical wood siding. Some of the windows have been replaced with Frank Lloyd Wright-style art glass casement units, one of the windows was replaced with glass block, and the remaining aluminum casement and fixed-pane units appear to be original. The primary entrance is accessed via a cast concrete porch which is partially enclosed with a brick wall. The building does not meet the NRHP and CRHR eligibility criteria for the reasons identified on the district record prepared for this subdivision; therefore the building does not contribute to a historic district and is not individually eligible for listing in the NRHP and the CRHR.

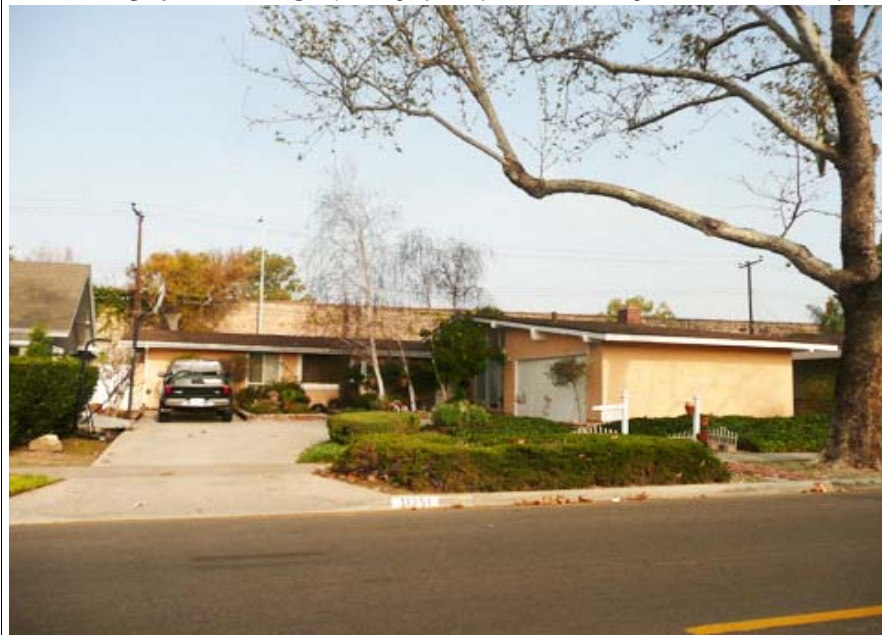
Facing west; 2/18/2010; Photo No.

* P3a. Description: (Describe resource and its major elements. Include design, materials, condition, alterations, size, setting, and boundaries.)
The one-story Ranch style building is 'L'-shaped in plan. The cross gabled roof, with boxed eaves, is clad in composition shingles. A brick chimney is located on the northern façade. The southern facing eave of the roof is accented with false beams. The exterior walls are clad in smooth textured stucco, and the eastern façade of the attached two-car garage is accented with scored stucco. The windows have been replaced with vinyl casement and fixed-pane units. The fixed-pane windows, with fritted glass, on the southern façade of the projecting bay located at the northern end of the primary (eastern) façade appear to be original. The primary entrance is raised and recessed. The building does not meet the NRHP and CRHR eligibility criteria for the reasons identified on the district record prepared for this subdivision; therefore the building does not contribute to a historic district and is not individually eligible for listing in the NRHP and the CRHR.

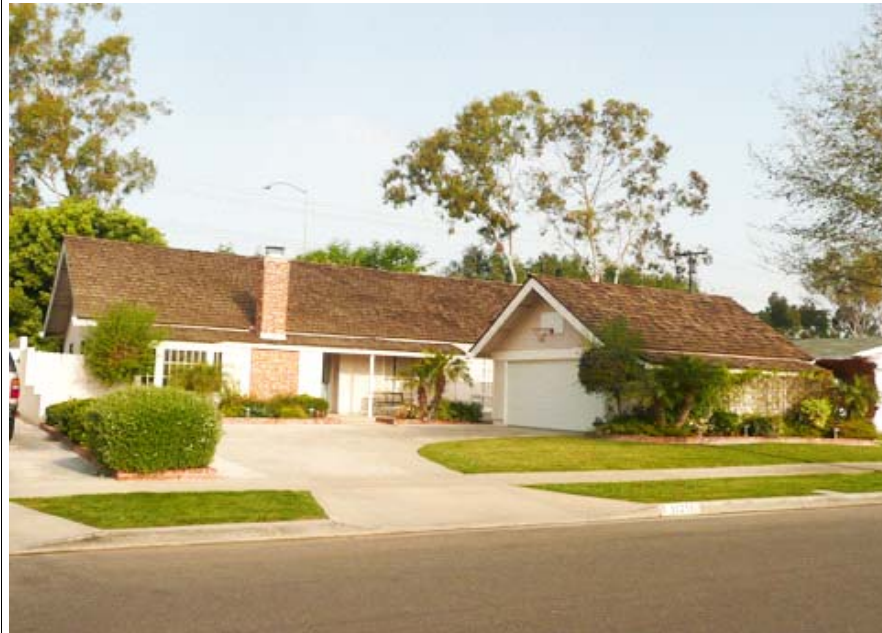
Facing the primary façade; 2/18/2010; Photo No. P1030900.jpg

* P3a. Description: (Describe resource and its major elements. Include design, materials, condition, alterations, size, setting, and boundaries.)
The one-story Ranch style building is rectangular in plan. The side gabled roof, with boxed eaves, is clad in wood shingles. A brick chimney and a small canted bay, with multi-light fixed-pane and casement windows accents the southern end of the primary (eastern) facade. The exterior walls are clad in smooth textured stucco. The multi-light wood sash windows appear to be original. The primary entrance is raised, and is accessed via a covered porch. A pent roof, with square wood posts, shelters the primary entry porch. A detached garage is located in the front of the parcel, and is of the same design and materials as the primary building on the parcel. The building does not meet the NRHP and CRHR eligibility criteria for the reasons identified on the district record prepared for this subdivision; therefore the building does not contribute to a historic district and is not individually eligible for listing in the NRHP and the CRHR.

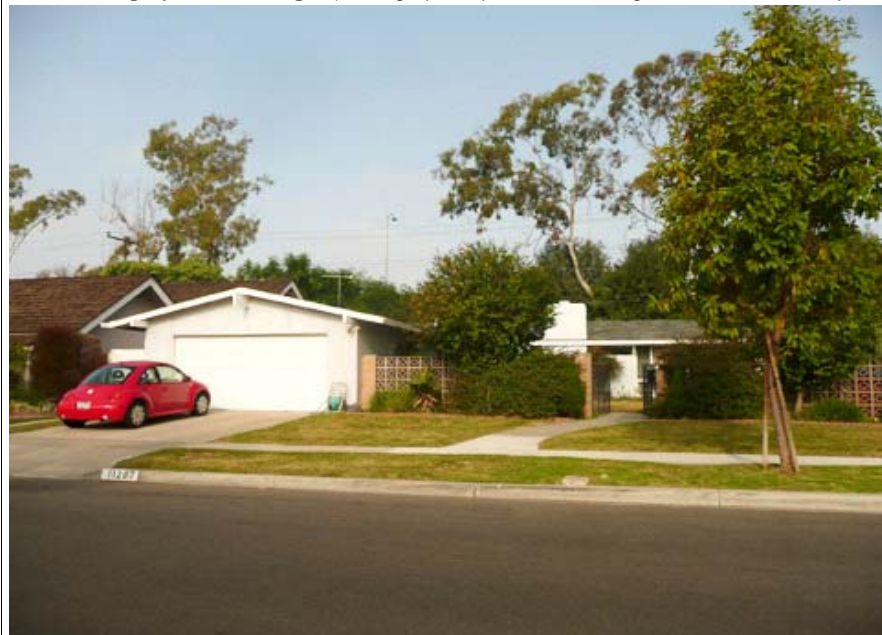
Facing the primary façade; 2/18/2010; Photo No. P1030901.jpg

* P3a. Description: (Describe resource and its major elements. Include design, materials, condition, alterations, size, setting, and boundaries.)
The one-story Ranch style building is 'L'-shaped in plan. The cross gabled roof, with boxed eaves, is clad in composition shingles. The front-facing gable is accented with false beams and false timbering. A brick chimney is prominently featured on the primary (eastern) façade. The exterior walls are clad in vertical wood siding, and the projecting attached two-car garage is clad in scored stucco. The windows have been replaced with vinyl casement and fixed-pane units. The primary entrance is raised, and accessed via a cast concrete porch which is partially enclosed with a brick wall. A concrete block and screening block wall, with metal gate, creates a private courtyard. The building does not meet the NRHP and CRHR eligibility criteria for the reasons identified on the district record prepared for this subdivision; therefore the building does not contribute to a historic district and is not individually eligible for listing in the NRHP and the CRHR.

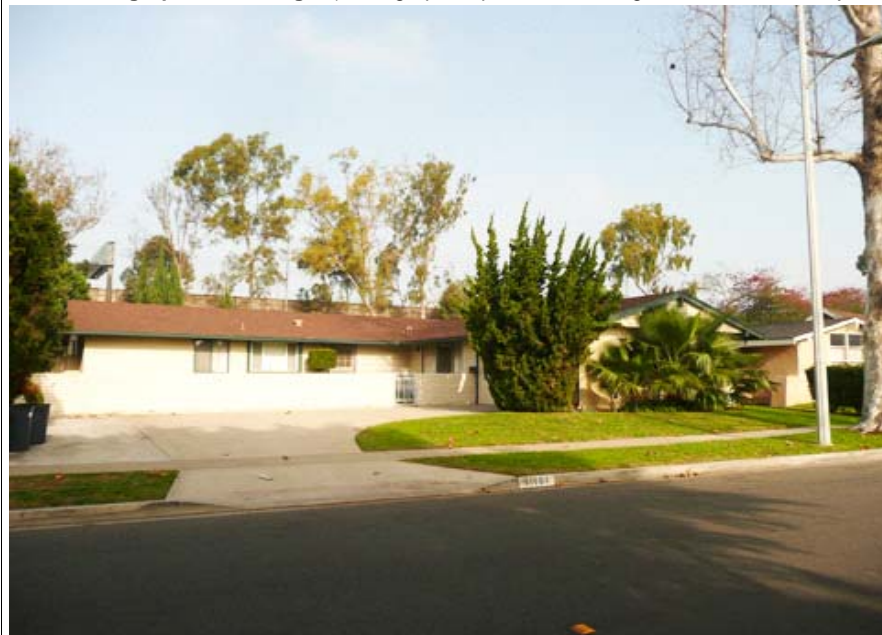
Facing the primary façade; 2/18/2010; Photo No. P1030902.jpg

* P3a. Description: (Describe resource and its major elements. Include design, materials, condition, alterations, size, setting, and boundaries.)
The one-story Ranch style building is 'L'-shaped in plan. The cross gabled roof, with boxed eaves, is clad in composition shingles. The front-facing gable is clad in wavy-edge horizontal wood siding and is accented with false beams. The exterior walls are clad in wavy-edge horizontal wood siding. The aluminum sliding and fixed-pane windows appear to be original, and are accented with wood surrounds. The primary entrance is accessed via a private courtyard which is enclosed with a brick wall and metal gate. The building does not meet the NRHP and CRHR eligibility criteria for the reasons identified on the district record prepared for this subdivision; therefore the building does not contribute to a historic district and is not individually eligible for listing in the NRHP and the CRHR.

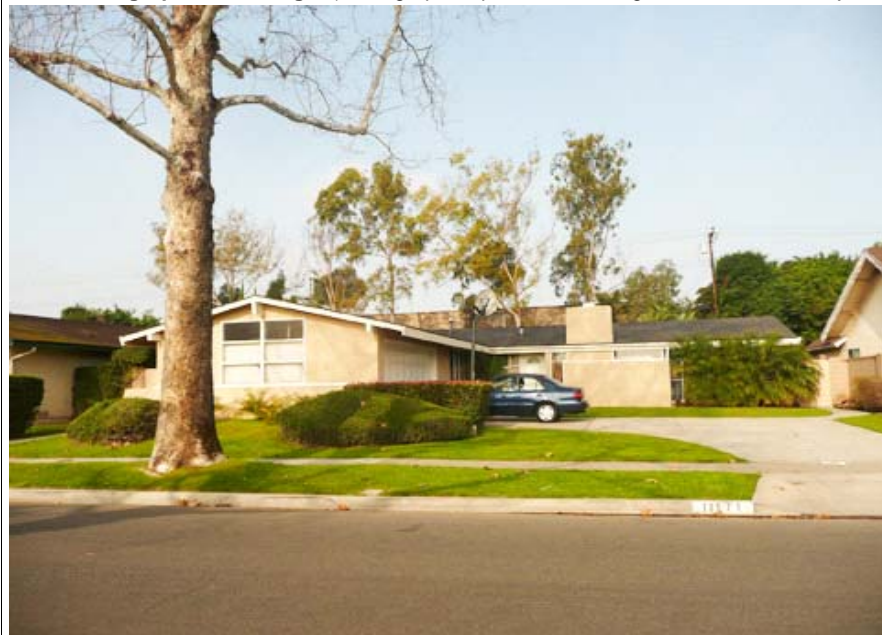
P5b. Description of Photo: (View, date, etc.)
Facing the primary façade; 2/18/2010; Photo No. P1030903.jpg

* P3a. Description: (Describe resource and its major elements. Include design, materials, condition, alterations, size, setting, and boundaries.)
The one-story Ranch style building is 'L'-shaped in plan. The cross gabled roof, with boxed eaves, is clad in composition shingles. The front-facing gable is accented with false beams. A brick chimney is prominently featured on the northern end of the primary (eastern) façade. The exterior walls are clad in smooth textured stucco, and the eastern façade of the projecting two-car garage is accented with brick veneer which extends beyond the façade to create battered walls. The garage is further accented with aluminum fixed-pane windows with pebble glass. The remaining windows on the primary (eastern) façade appear to have been replaced with vinyl casement and fixed-pane units. The primary entrance is raised, and accessed via a small cast concrete porch. The building does not meet the NRHP and CRHR eligibility criteria for the reasons identified on the district record prepared for this subdivision; therefore the building does not contribute to a historic district and is not individually eligible for listing in the NRHP and the CRHR.

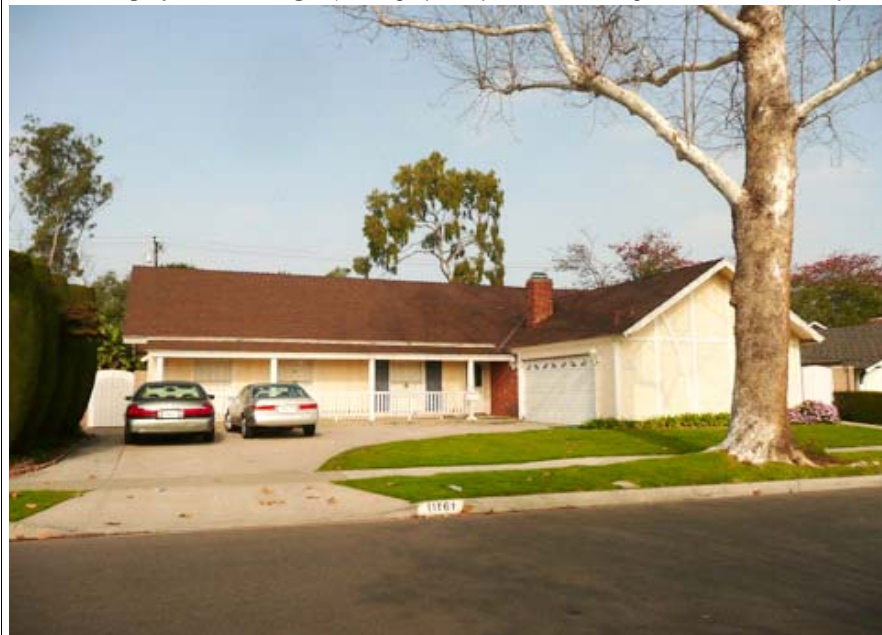
P5b. Description of Photo: (View, date, etc.)
Facing the primary façade; 2/18/2010/ Photo No. P1030904.jpg

* P3a. Description: (Describe resource and its major elements. Include design, materials, condition, alterations, size, setting, and boundaries.)
The one-story Ranch style building is 'L'-shaped in plan. The cross gabled roof, with boxed eaves, is clad in composition shingles. A brick chimney is located in the east-facing corner of the 'L'-shaped roof. The exterior walls are clad in vertical board and batten siding, brick veneer, and the east face of the projecting two-car garage is clad in smooth textured stucco with Tudor-style false timbering accents. The batten used for the Tudor-style detailing is further accented to appear adzed. The ten-over-ten wood sash windows appear to be original, and one window is accented with shutters. The primary entrance is raised, and accessed via a covered porch which spans the southern end of the primary (eastern) façade. The roof overhangs to shelter the primary entry porch, and is supported by square wood posts, with a simple wood railing.

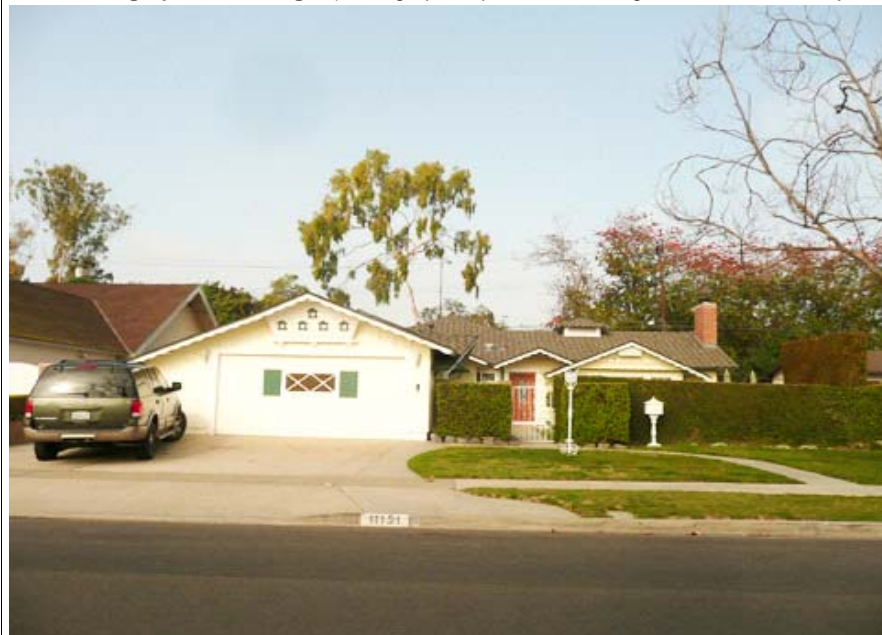
P5b. Description of Photo: (View, date, etc.)
Facing the primary façade; 2/18/2010; Photo N. P1030905.jpg

* P3a. Description: (Describe resource and its major elements. Include design, materials, condition, alterations, size, setting, and boundaries.)
The one-story Ranch style building is 'L'-shaped in plan. The cross gabled roof, with boxed eaves, is clad in composition shingles. A pyramidal roof crest is visible on the west face of the roof, and it is not known if this is original to the building. A cupola is located towards the northern end of the roof crest, and a brick chimney is located on the northern façade. The front-facing gables are accented with scalloped barge board. The southern and northern front-facing gables are further accented with dovescotes, and northern front-facing gable is also accented with brackets. The exterior walls are clad in vertical board and batten, smooth textured stucco, and wavy-edge horizontal wood siding. Some of the original multi-light wood sash are extant, and some of the windows have been replaced with vinyl sash units. A wall hidden by shrubbery creates a private courtyard. The pivoting wood garage door is accented with a diamond-paned fixed-pane window with shutters, and it is not known if the garage has been converted to living space.

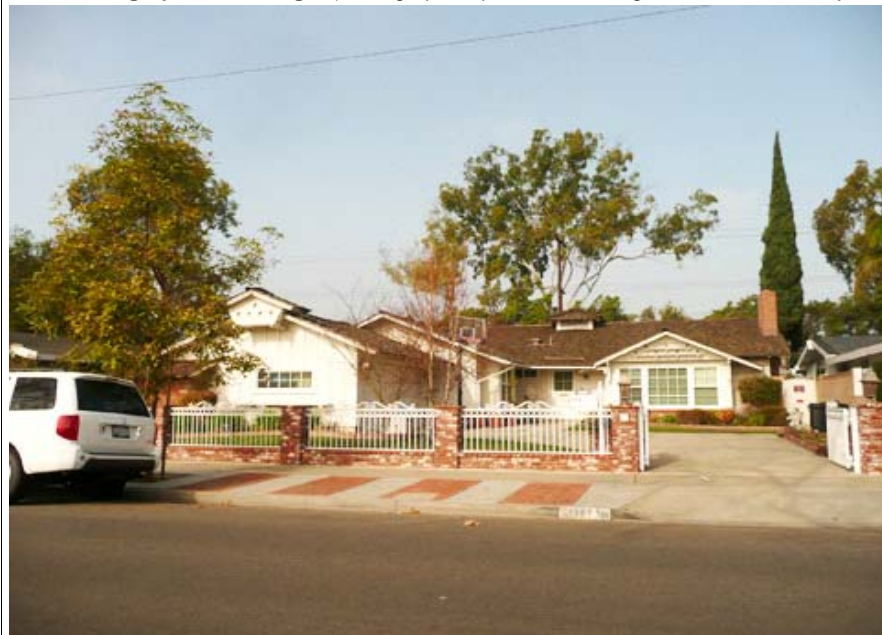
P5b. Description of Photo: (View, date, etc.)
Facing the primary façade; 2/18/2010; Photo No. P1030906.jpg

* P3a. Description: (Describe resource and its major elements. Include design, materials, condition, alterations, size, setting, and boundaries.)
The one-story Ranch style building is 'L'-shaped in plan. The cross gabled roof, with boxed eaves, is clad in wood shingles. A brick chimney is located on the north façade, and a cupola is located near the northern end of the roof crest. The southern and northern front-facing gables are accented with dovescotes, and the northern gable is further accented with brackets. The exterior walls are clad in vertical board and batten siding, smooth textured stucco, and horizontal wavy-edge wood siding. The southern end of the eastern façade of the attached two-car garage is further accented with a half-height bay with a composition shingle clad pent roof and brick veneer. The windows have been replaced with vinyl sash and fixed-pane units. The primary entrance is recessed and accessed via a cast concrete porch. A modern brick and metal fence encloses the perimeter of the parcel.

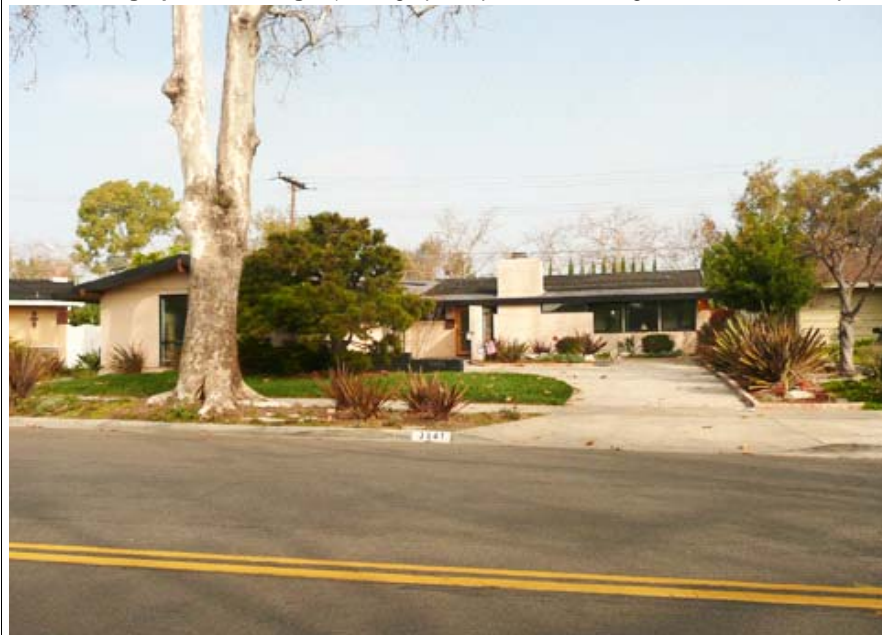
Facing north; 2/18/2010; Photo No.

* P3a. Description: (Describe resource and its major elements. Include design, materials, condition, alterations, size, setting, and boundaries.)
The one-story Ranch style building is 'L'-shaped in plan. The cross gabled roof, with boxed eaves, is clad in composition shingles and solar material. The front-facing gable is accented with false beams, and a brick chimney is prominently located on the eastern bay of the primary (southern) façade. The exterior walls are clad in smooth textured stucco, and the garage facades are accented with scored stucco. The windows appear to have been replaced with modern anodized aluminum fixed-pane and casement units. The primary entrance is recessed, and a brick wall partially encloses the entry porch.

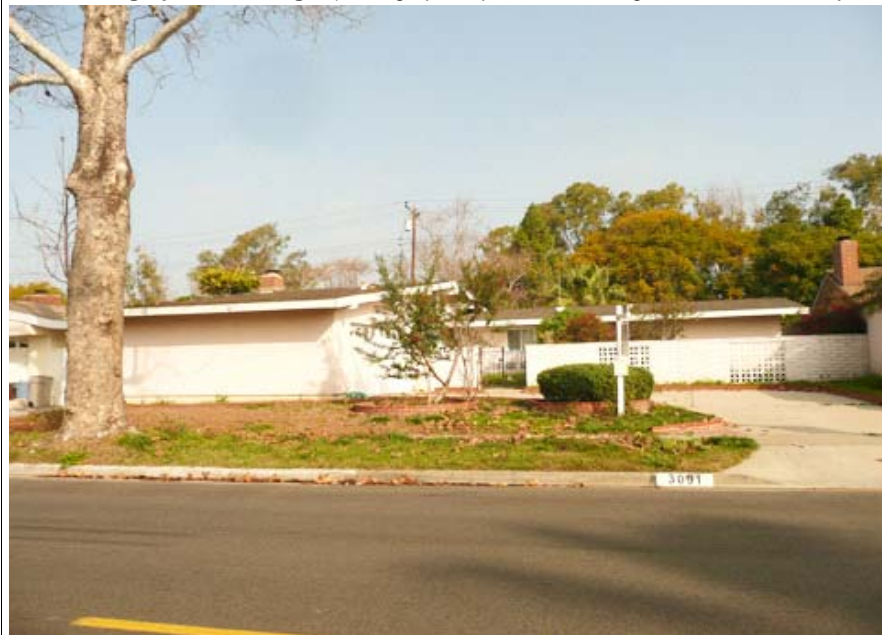
Facing north; 2/18/2010; Photo No.

* P3a. Description: (Describe resource and its major elements. Include design, materials, condition, alterations, size, setting, and boundaries.)
The one-story Ranch style building is "T"-shaped in plan. The side gabled roof is clad in composition shingles. The east face of the roof on the western bay is accented with false beams typical of the Post and Beam architecture style. A brick chimney is located on the western end of the north face of the roof. Some of the aluminum fixed-pane and casement windows are extant, and some have been replaced with vinyl units. The transom windows are accented with fritted glass. A brick and concrete screening block wall, with metal gate, creates a private courtyard. The southern façade of the attached two-car garage is accented with scored stucco.

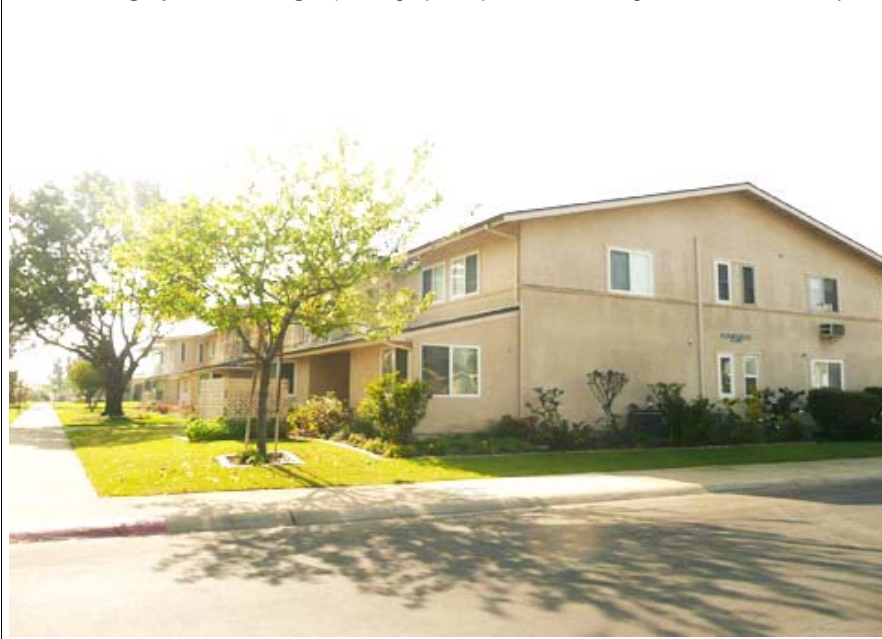
Facing southeast; 2/18/2010; Photo No.
P1030913.jpg

* P3a. Description: (Describe resource and its major elements. Include design, materials, condition, alterations, size, setting, and boundaries.)
The two-story building is rectangular in plan, and is symmetrical in plan. The side gabled roof is clad in composition shingles. The exterior walls are clad in smooth textured stucco. Fenestration consists of three sections or balconies spanning the long side of the rectangular building with paired windows separating the courtyards/balconies. The majority of the windows have been replaced with vinyl sliding units, and the remaining original windows are aluminum sliding units. Access to the units is through two open-air breezeways, with central stairways. The elevators installed to improve access appear to be an alteration. The building is a contributor to the Leisure World National Register of Historic Places-eligible historic district.
